RESEARCH MEMORANDUM

RESULTS OBTAINED FROM THIRD FLIGHT OF NORTHROP

X-4 AIRPLANE (A.F. NO. 46-676)

By Walter C. Williams

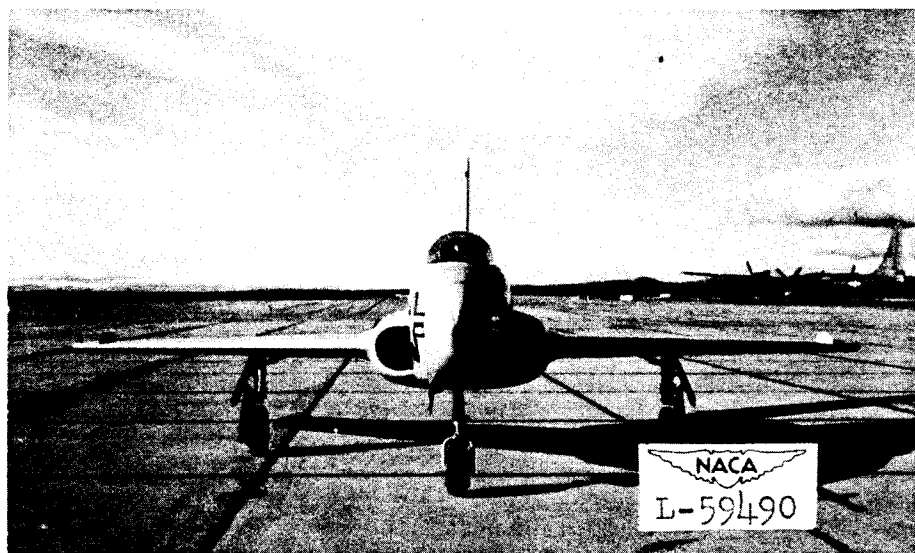
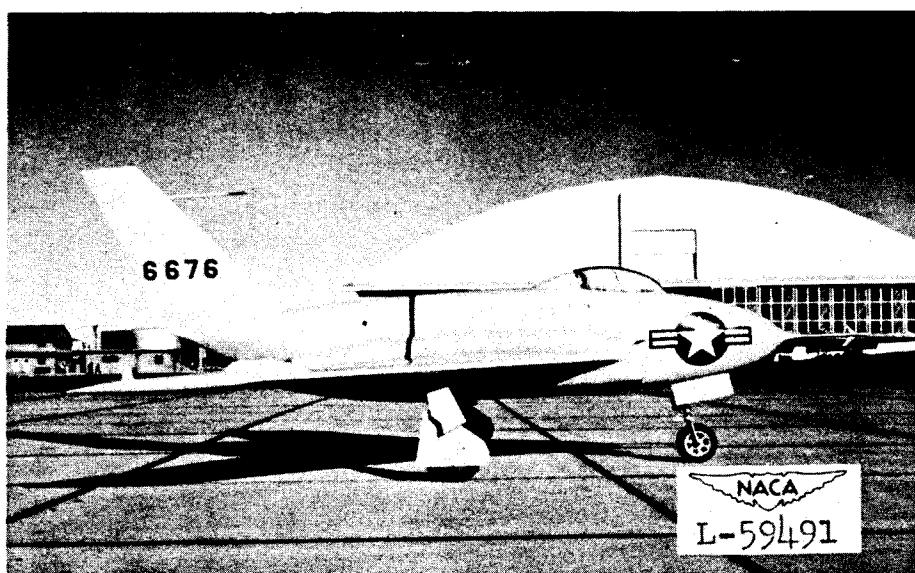
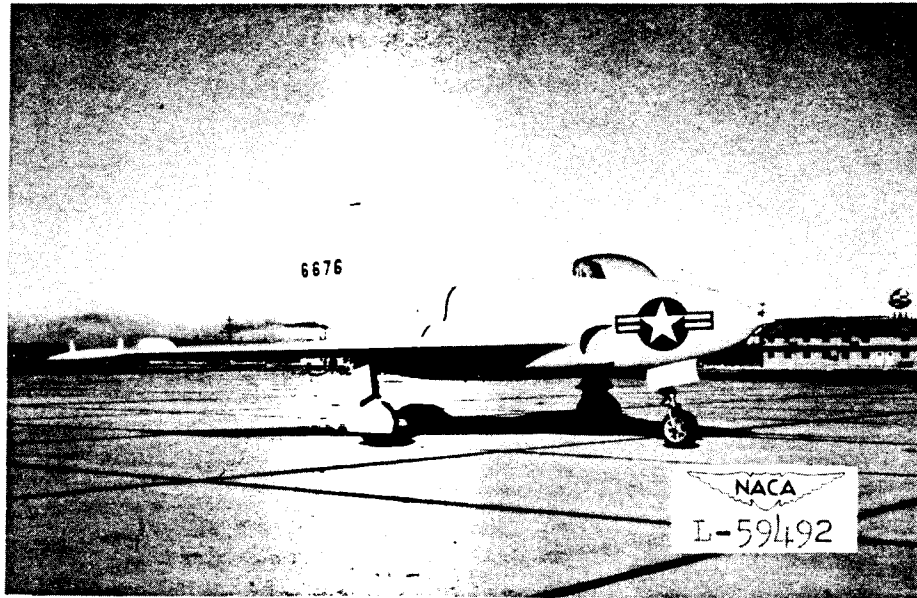
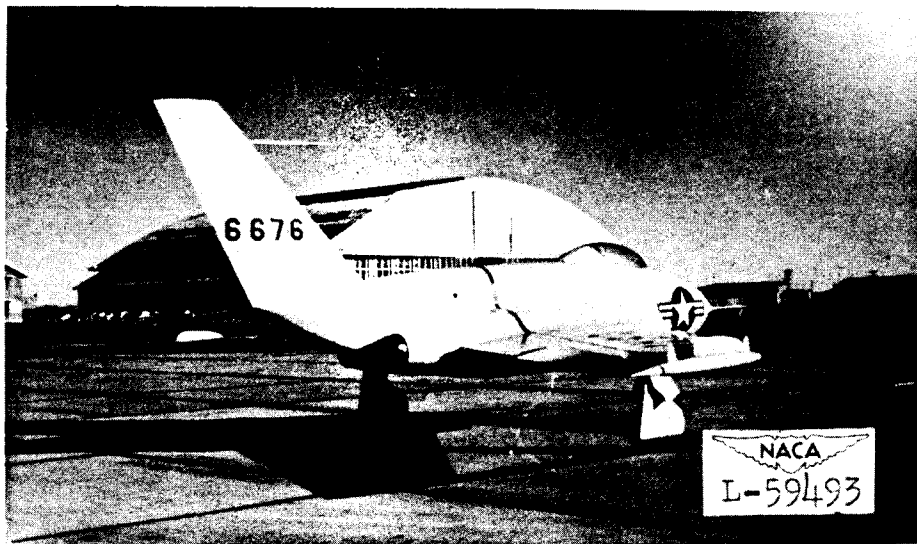
Figure 1.- Photograph of Northrop X-4 airplane.

Figure 1.- Concluded.

The Northrop X-4 airplane is a semitailless research airplane having a vertical tail but no horizontal tail surfaces. It is powered by two Westinghouse J30-WE-7-9 engines and is designed for flight research in the high-subsonic-speed range. Photographs of the airplane are presented as figure 1 and a three-view drawing as figure 2. Table I lists the physical characteristics of the airplane.

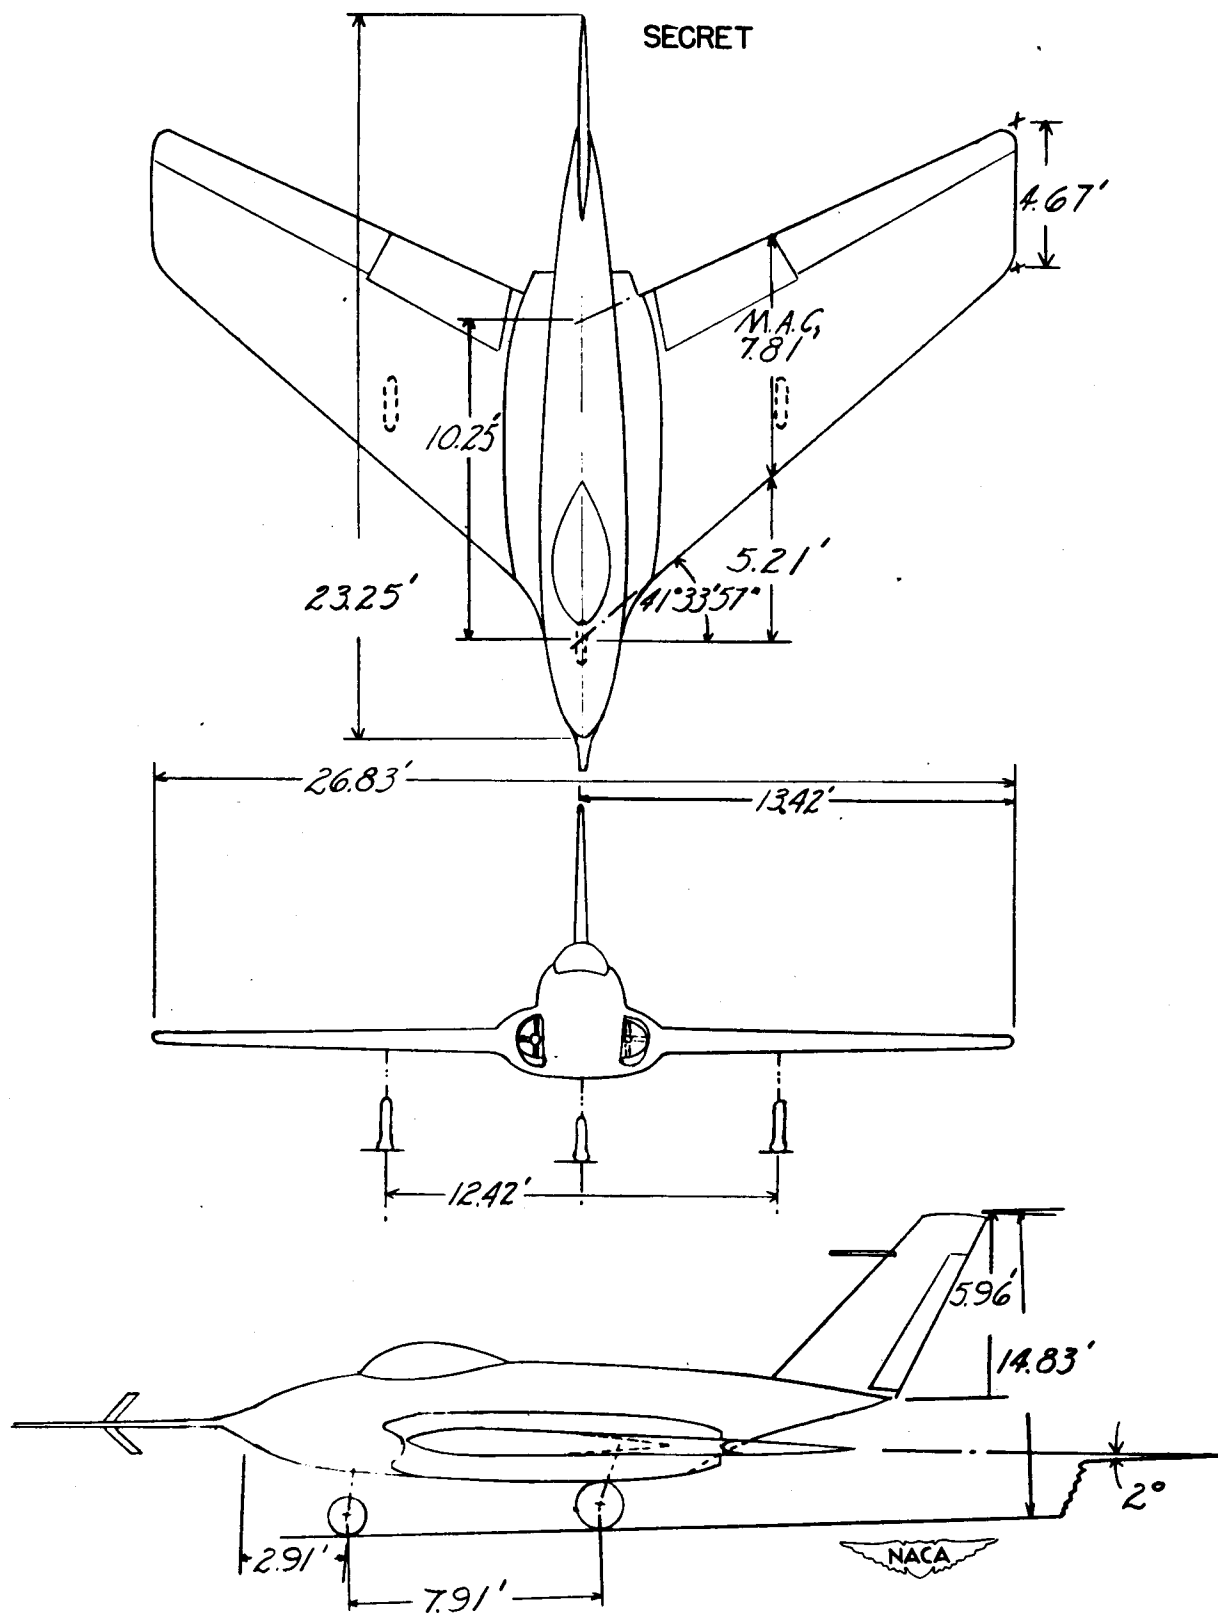
Figure 2.- Three-view drawing of Northrop X-4 airplane.

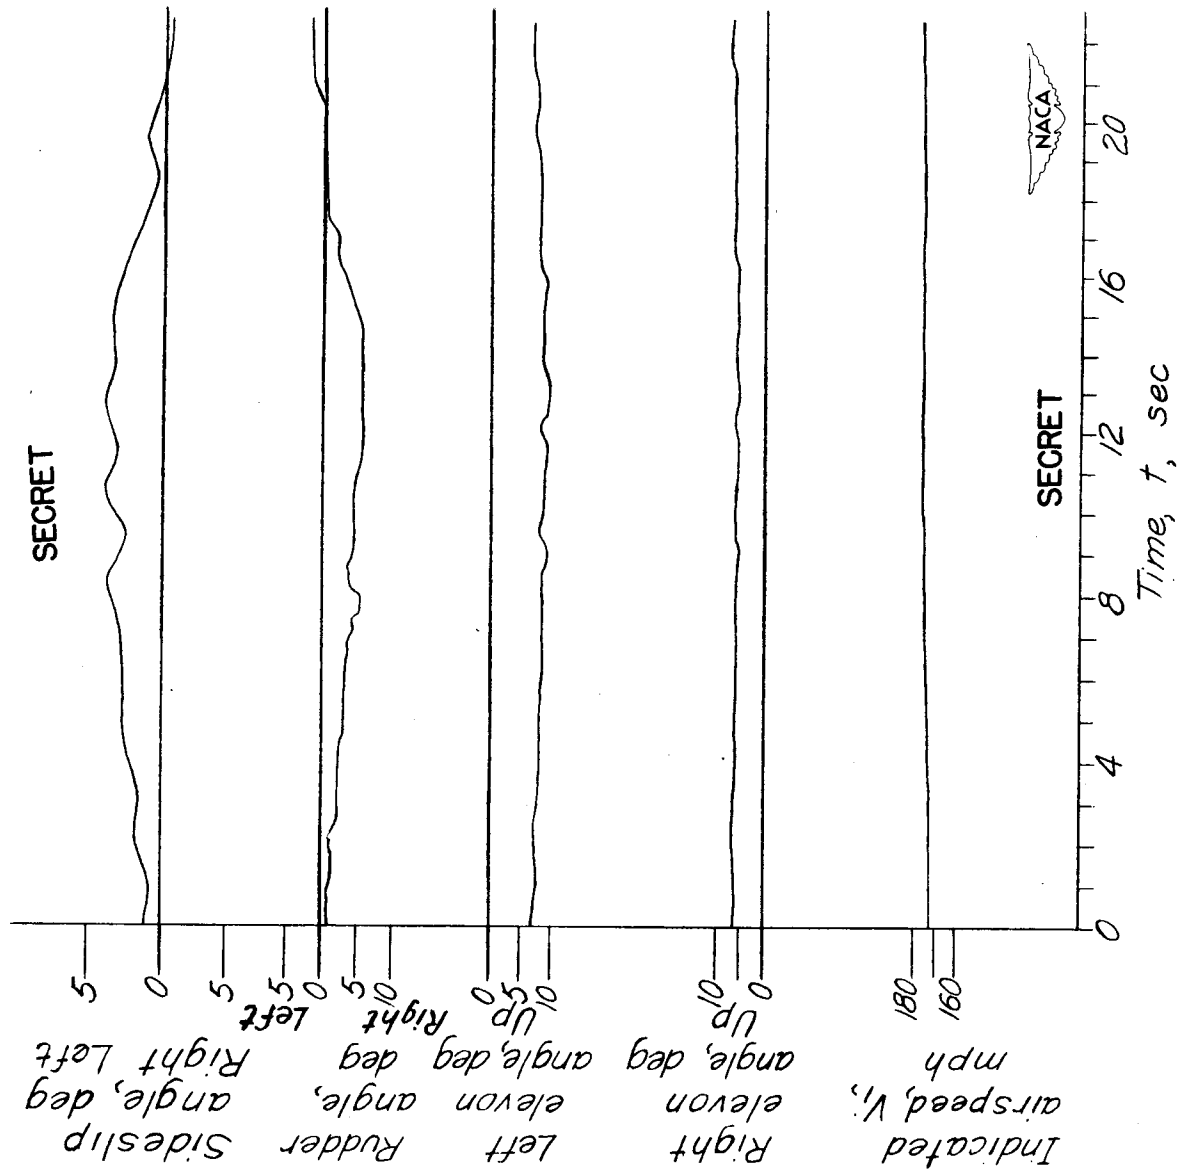
Figure 3.— Time history of a left sideslip. Northrop X-4 airplane.

The pilot took records in these sideslips as he slowly increased sideslip and then attempted to maintain a steady condition. Time histories of these two runs are presented in figures 3 and 4. From these data, figure 5 was prepared which presents the variation of rudder and lateral-control position with sideslip angle. There is scatter in these data, particularly those pertaining to the lateral control, but as can be seen in figures 3 and 4, the control was not moved smoothly, which resulted in some oscillation in sideslip. It can be seen from figure 5, however, that the directional stability as measured by the variation of rudder position with sideslip angle is high, approximately 1.7° of rudder per degree sideslip. The effective dihedral as shown by the variation of lateral control with sideslip angle is positive.

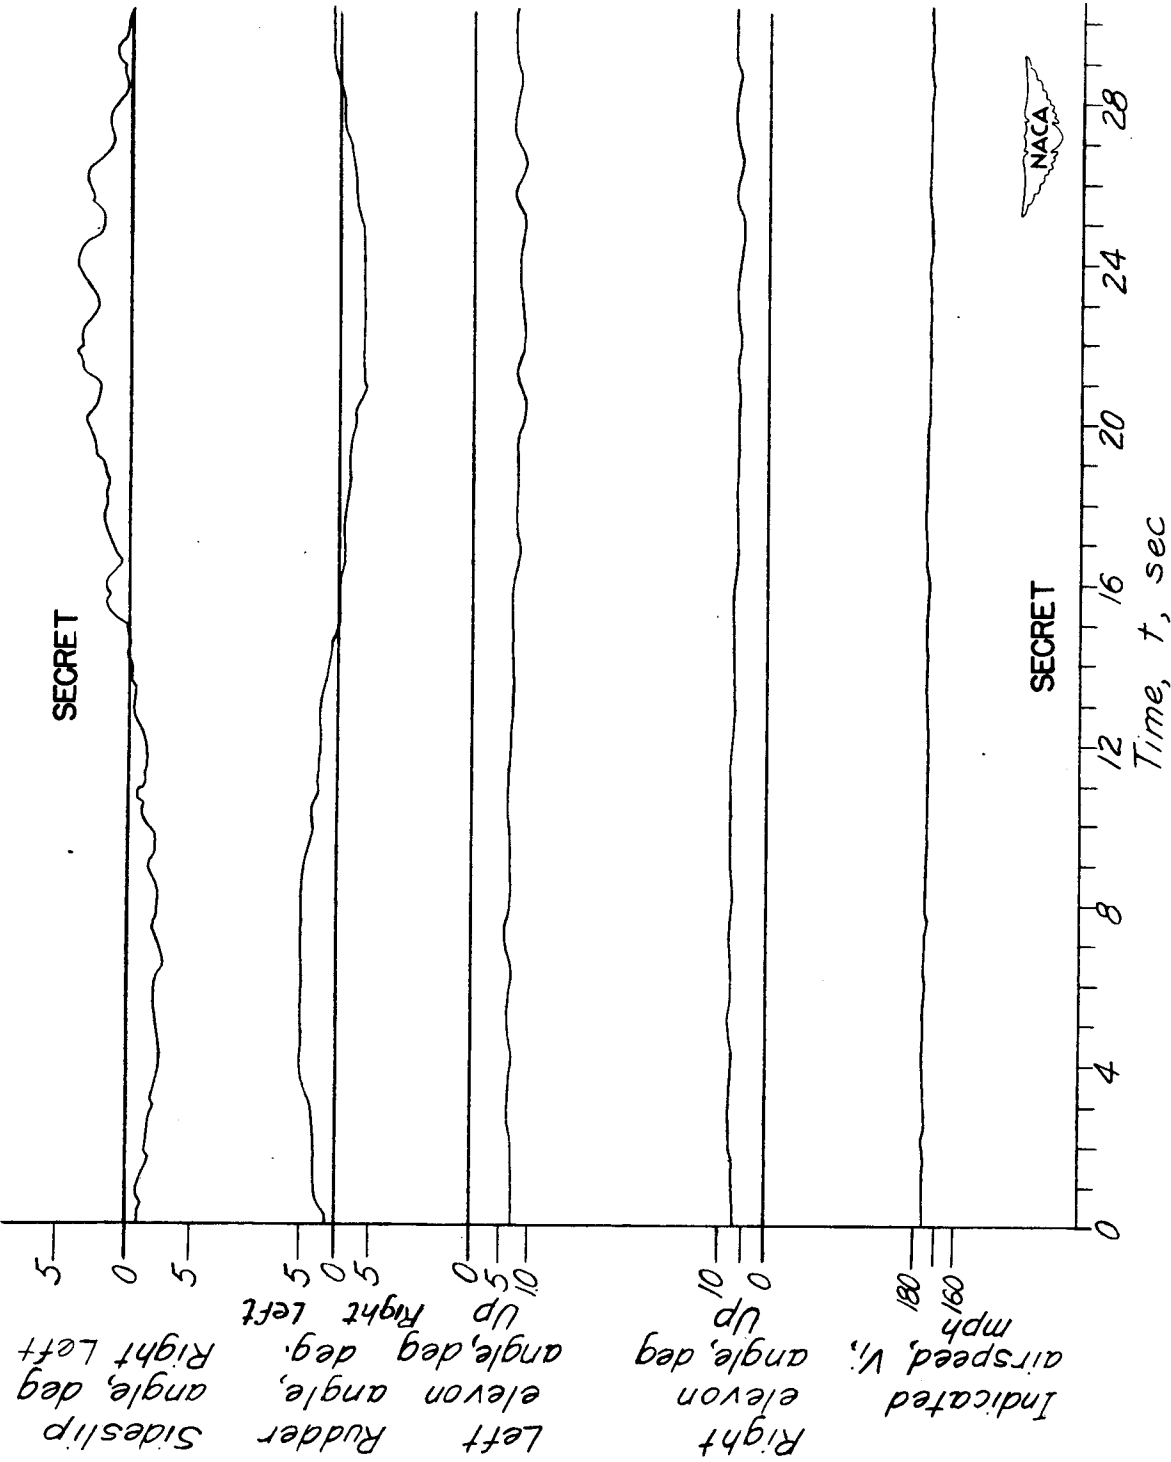
Figure 4.- Time history of steadily changing sideslip. Northrop X-4 airplane.

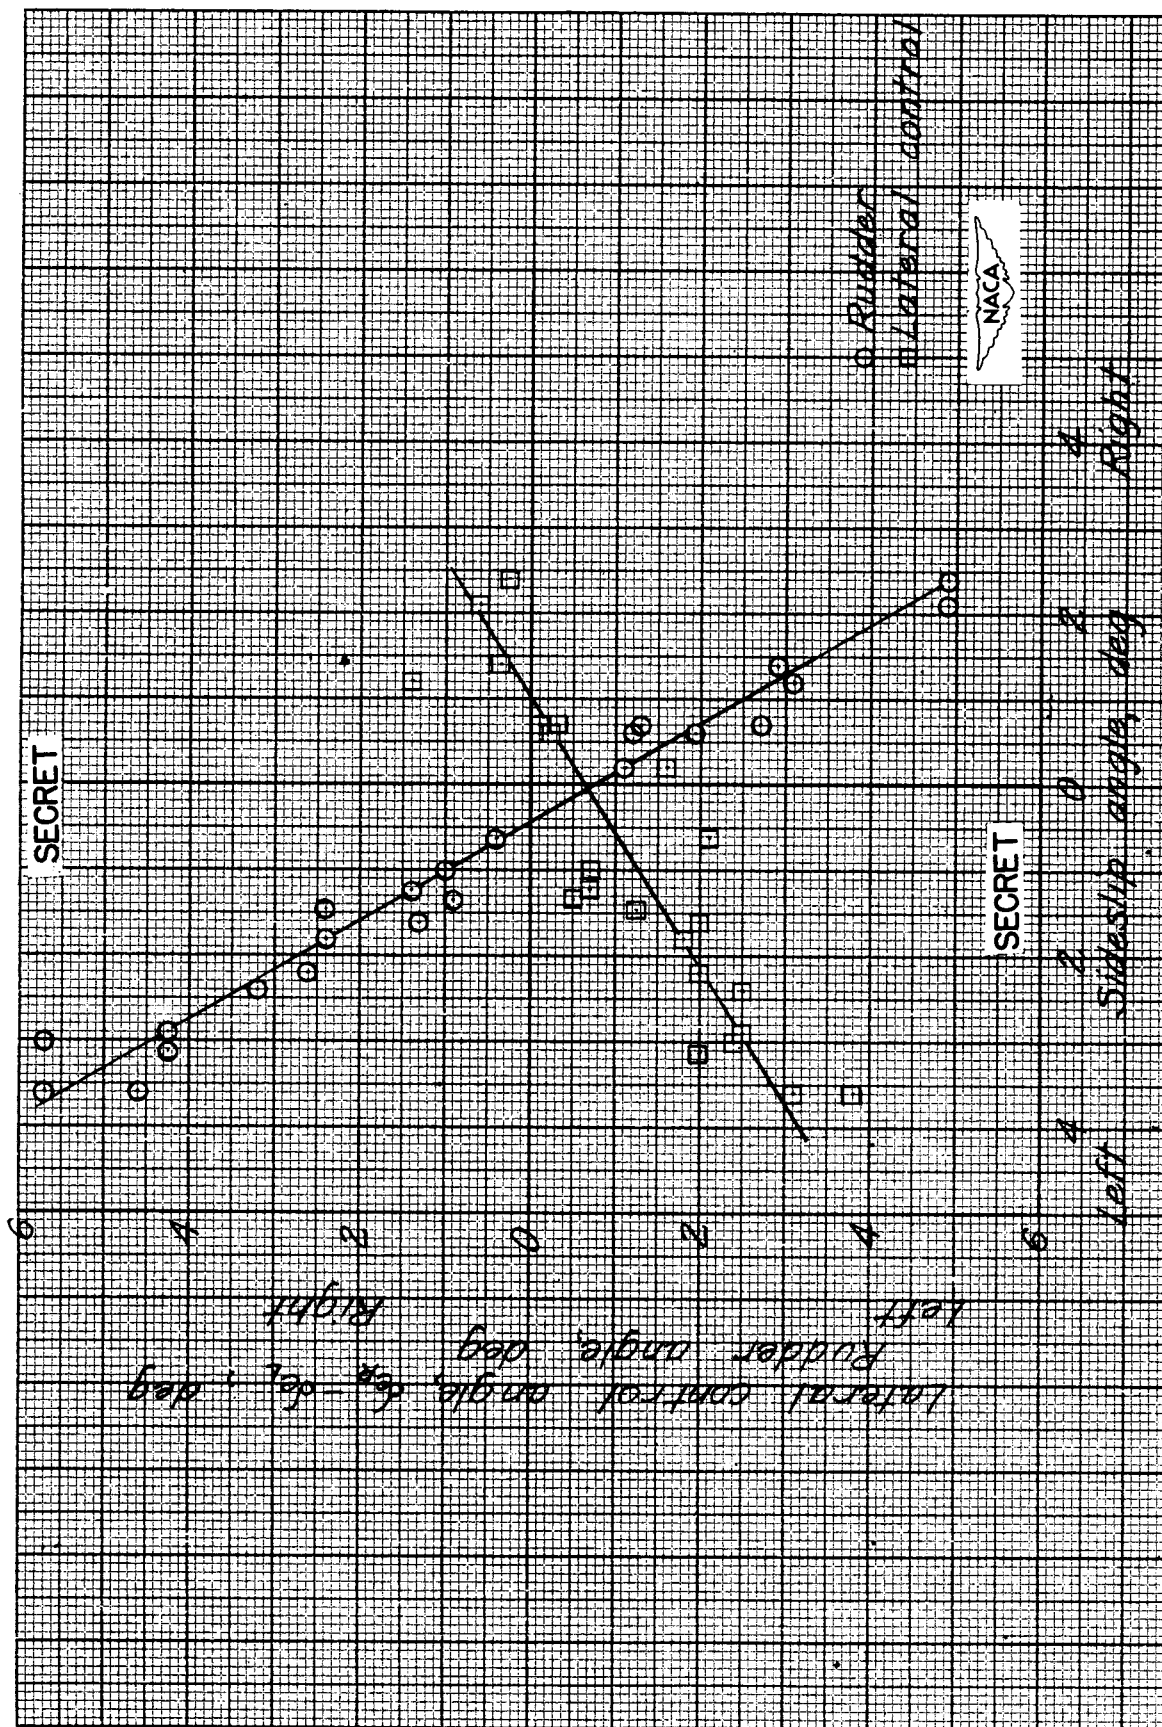
Figure 5.- Steady sideslip characteristics. Northrop X-4 airplane.

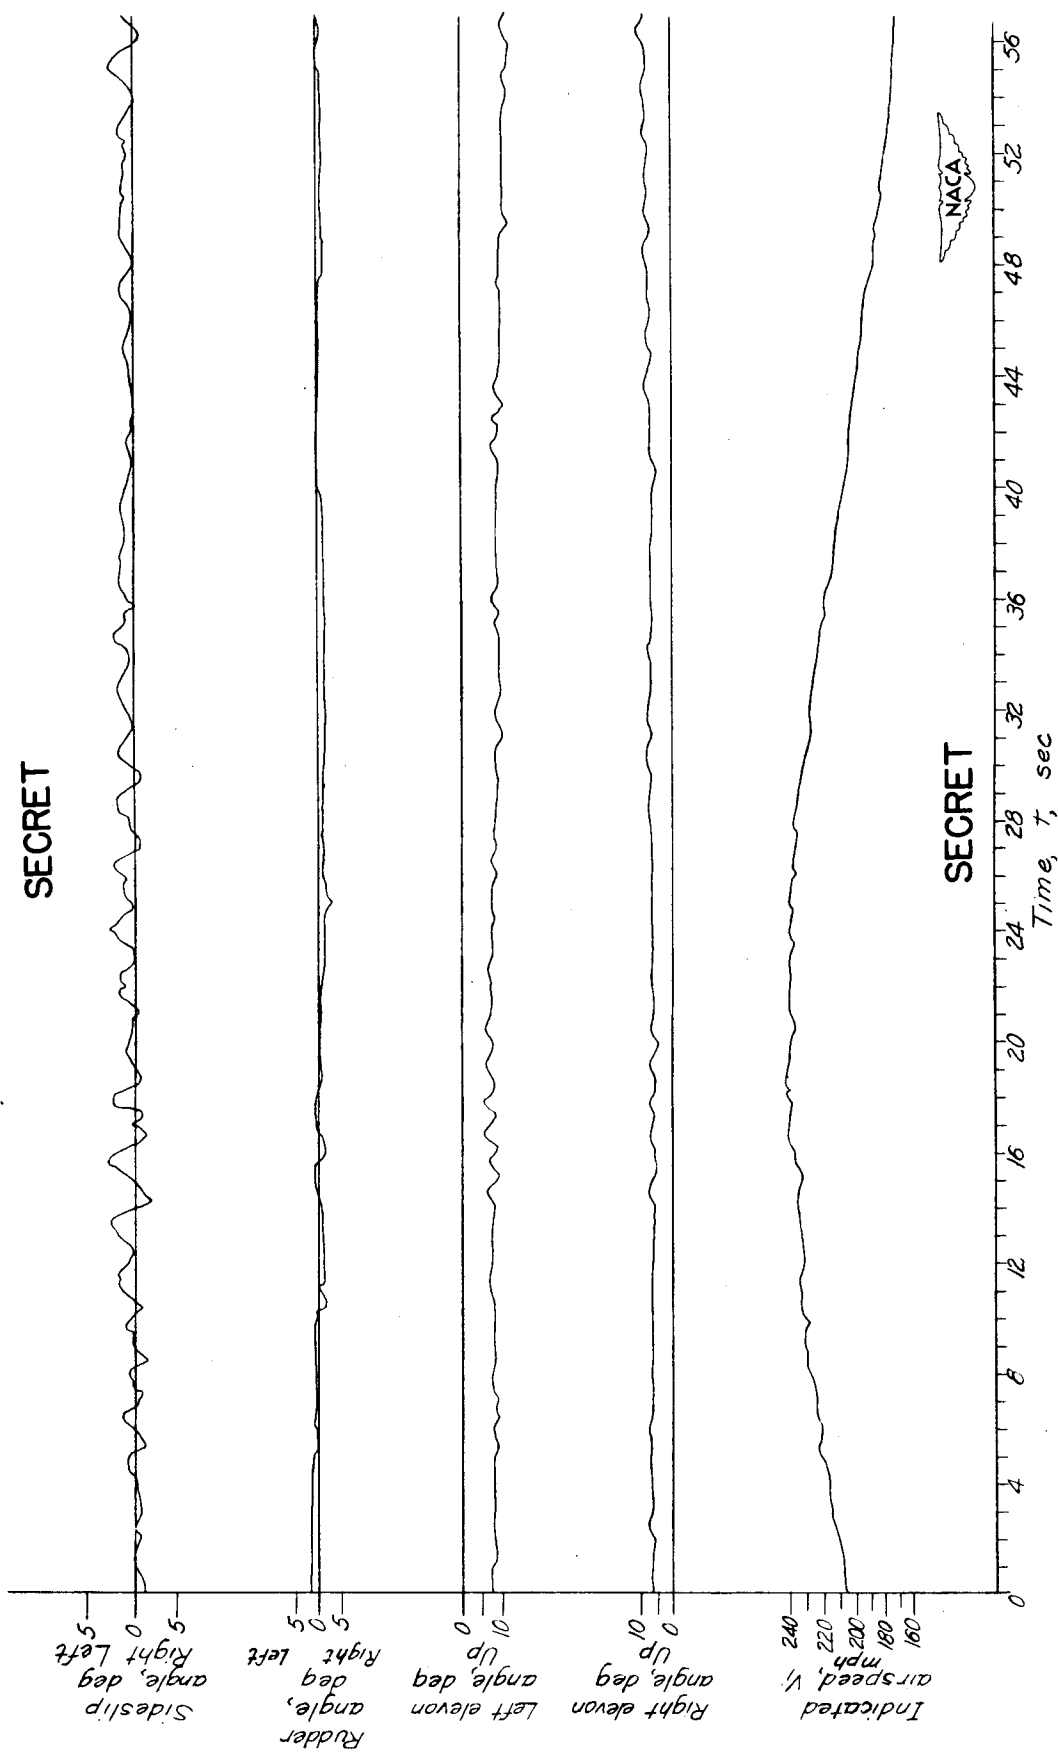
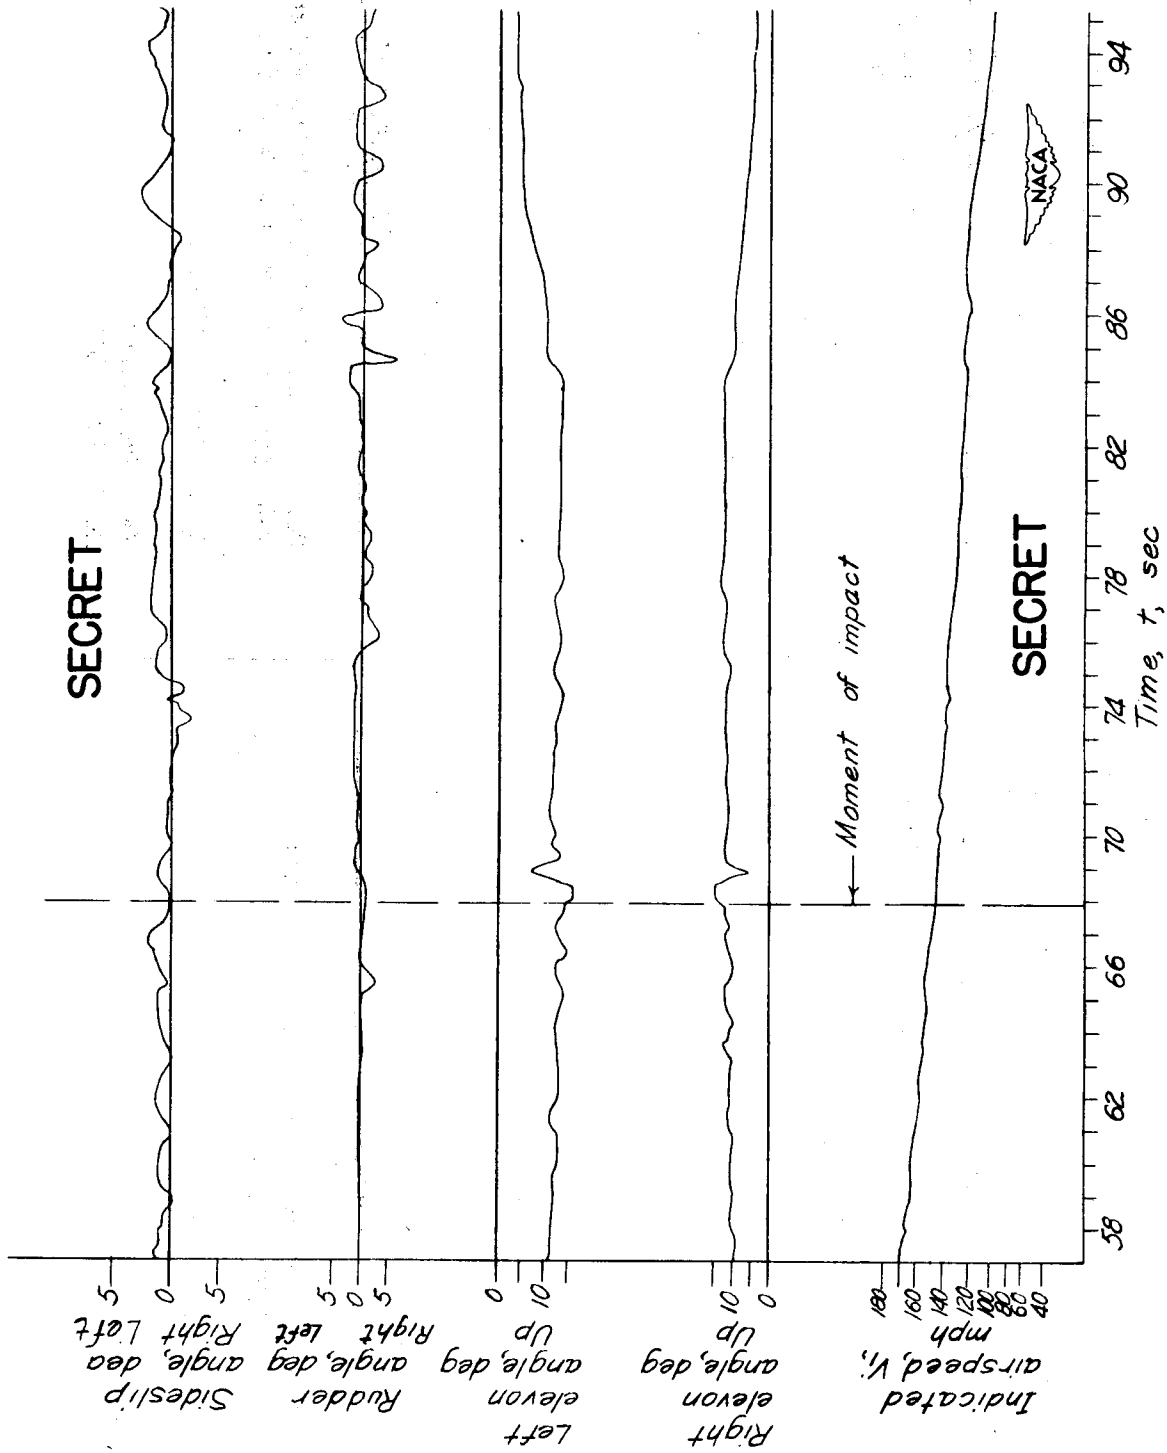
Figure 6.- Time history of landing approach and landing. Northrop X-4 airplane.

Figure 6.- Concluded.

A time history of the landing approach and landing is given in figure 6. The landing was quite similar to that made in flight 2 (reference 2) with touchdown at about the same speed, 150 miles per hour. The landing was made with flaps up. The poor damping of the lateral oscillation reported in the previous flight (reference 2) was still present, as can be seen by examination of the sideslip record. The pilot reported that the rudder forces were higher with the trailing-edge strip but could not comment on the lateral oscillation, since it was most objectionable on the previous flight above 250 miles per hour, and he did not go to such speeds in this flight.
